# THE BOARDMAN-OTTAWAY: A RIVER REBORN

**The Boardman-Ottaway: A River Reborn**

is the largest comprehensive dam removal effort in Michigan's history and one of the most significant in the Great Lakes Basin. The overall project involved removing three dams (Brown Bridge, Boardman and Sabin) on the Boardman River, originally known as the Ottaway by the Ojibwa and Odawa Native Americans. The project reconnects 160 miles of river and tributaries that were fragmented by the dams for 126 years. An estimated seven miles of river and tributaries that were buried under impoundments are now daylighted, and their adjacent floodplains and upland corridors restored. Outdoor recreation abounds with paddlers, hikers and anglers enjoying the recovered river, and community safety is improved with removal of the aging infrastructure. Fish, wildlife and aquatic insects thrive in the coldwater, gravel habitat that was once forgotten under the sediment-laden warmwater impoundments.

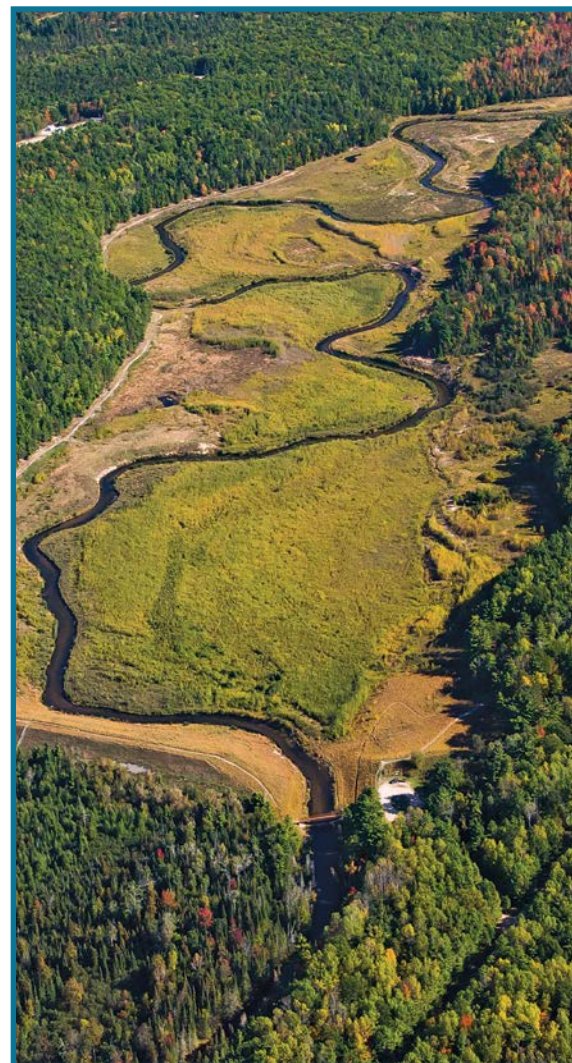
The river meanders once again through the former impoundment. A foot bridge now connects trails where the powerhouse once stood. (October 2019)

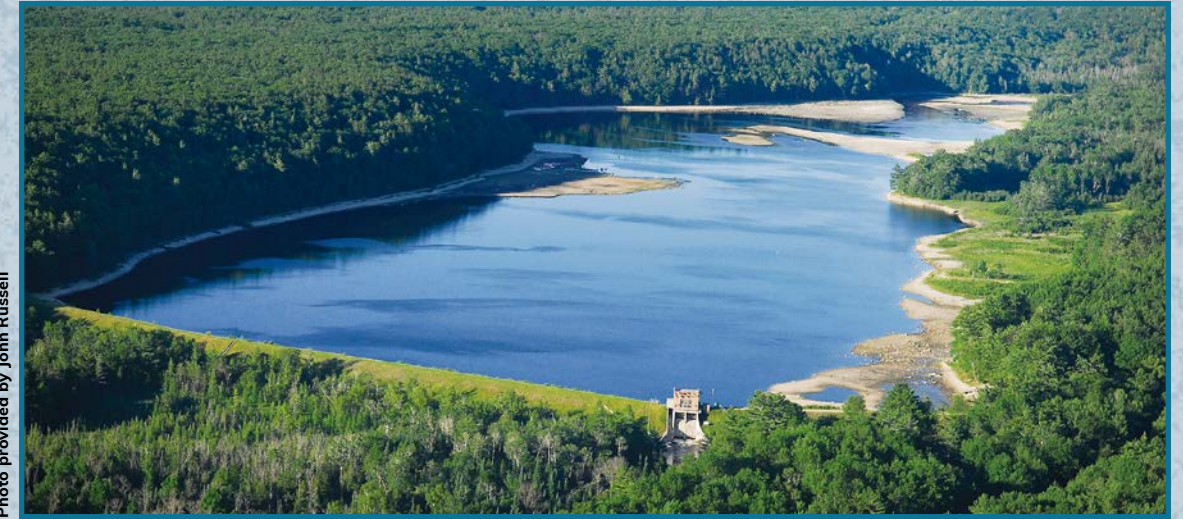
Due to an inadequate spillway, two drawdowns were required exposing the heavy sand filling Brown Bridge Pond prior to dam removal. (Summer 2010)

- Impoundment 191 acres
- Drainage area of 151 square miles
- 1.4M cubic yards of sediment impounded during dam operation
- Decommissioned in 2006, pond lowered 3' in 2008 and 6' in 2011 due to limited spillway capacity

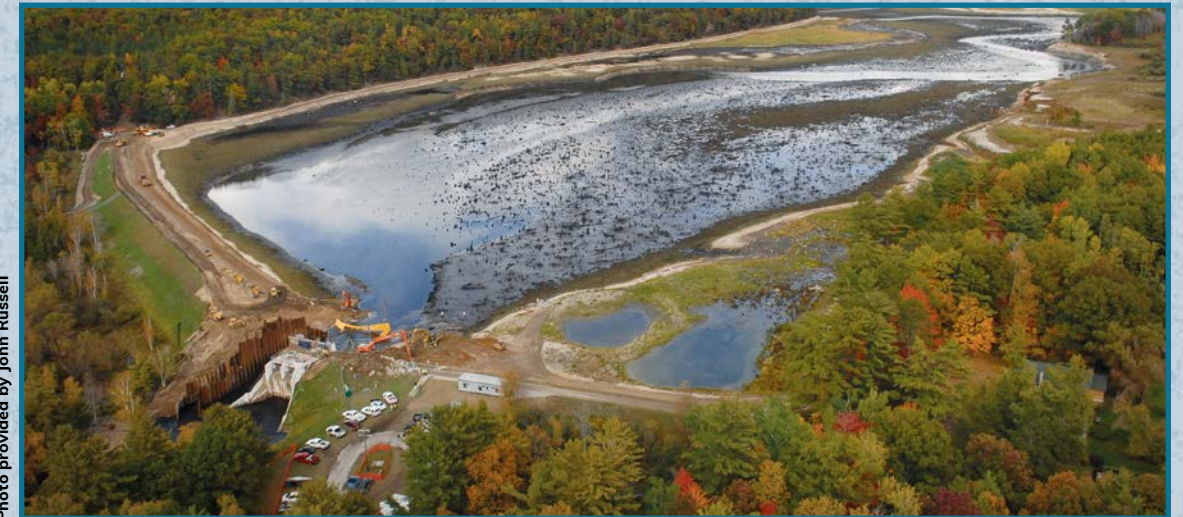
As the pond was drawn down, tree stumps surfaced, dotting the sand and sediment that had built up over the years. (September 2012)

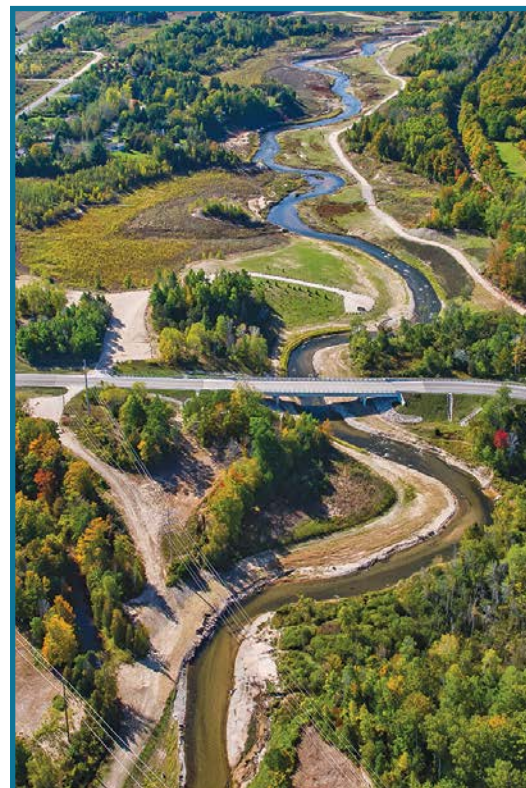
The river was returned to its original channel flowing under the new Robbins Bridge on Cass Rd. (Oct. 2019)

Another construction highlight included building the new Robbins Bridge at Cass Road to replace the one-lane crossing over the powerhouse. Fortunately, the Grand Traverse County Road Commission and Michigan DOT provided \$3.31M in construction funds and sequenced it in 2016 so that the 252’ span bridge could be built in “the dry” a year before dam removal. The bridge was positioned over the historic river channel, where the river would soon be returned the following year.

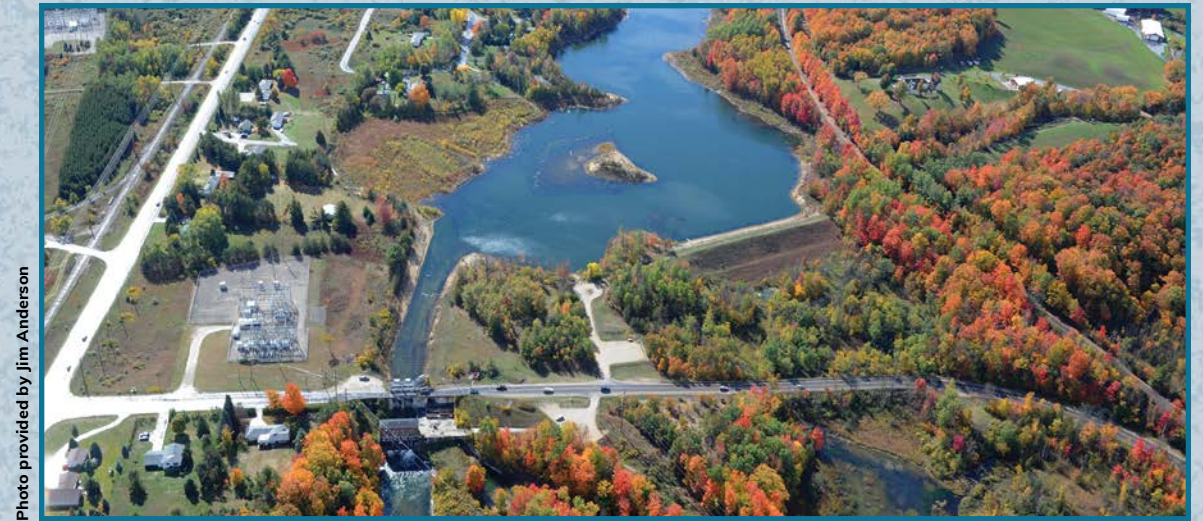
The Boardman Dam impoundment. Note the powerhouse and dam, called the core wall, are separate structures. (October 2016)

- Dam removal in 2017
- Dam height of 43’ with a head of 41’
- Dam length of 650’ long earthen embankment comprised of fill, concrete, steel rod and sheet pile with a detached brick powerhouse and spillway 400’ to the west

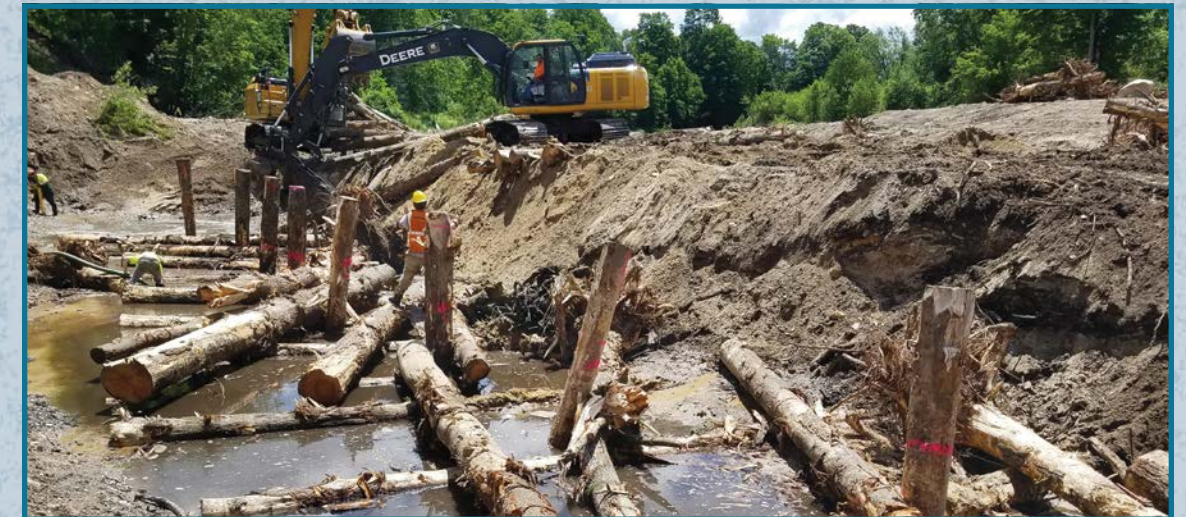
Logs and intact roots are recessed into streambanks and secured to the stream bottom to provide habitat and strengthen outside bends. (June 2017)

- 138 log piles, 214 logs, and 171 logs with intact roots placed for instream habitat and streambank protection
- 280’ of coconut fiber logs and 520’ whole tree revetments installed along base of streambanks

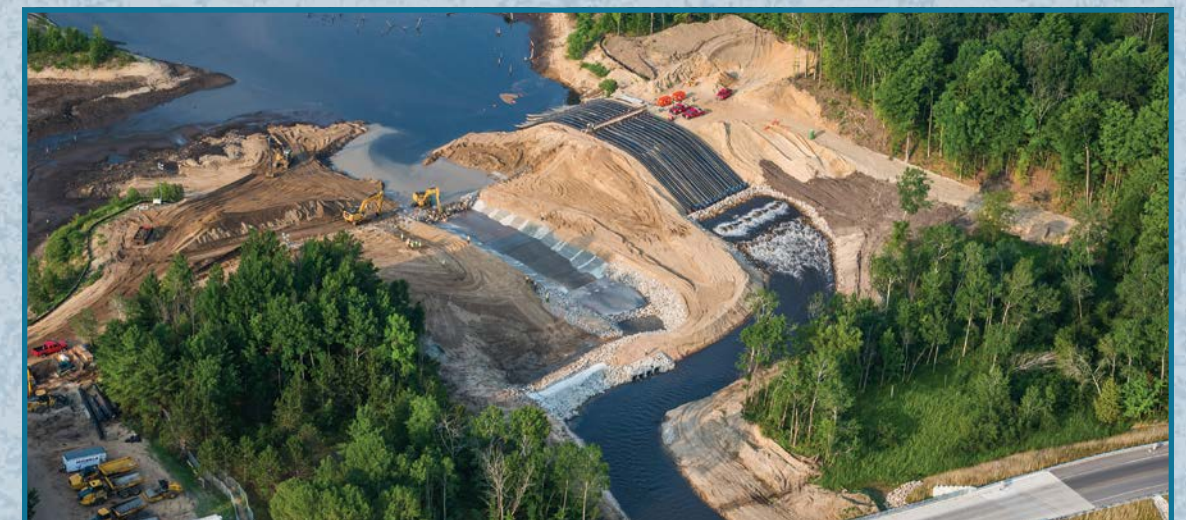
Gravity-fed siphons lowered the impoundment 21’ and an auxiliary spillway (left) drained the remaining water so the siphons could be removed and the river channel built in their place. (July 2017)

Of all three dams, the Boardman impoundment, known locally as “Keystone Pond,” had the largest amount of sediment to move around to recreate the river channel due in part to the 1961 failure of the Keystone Dam 2 miles upstream. A construction highlight was that 14 gravity-fed siphons were used to drain the pond 21’ down at Boardman Dam. The siphons were comprised of 30” diameter pipes made of high-density polyethylene, fused together to make 300’ lengths. They were individually operated and monitored 24 hours a day at varying capacity according to stream flow and rain events so that the impoundment was drawn down 6”-12” per day.

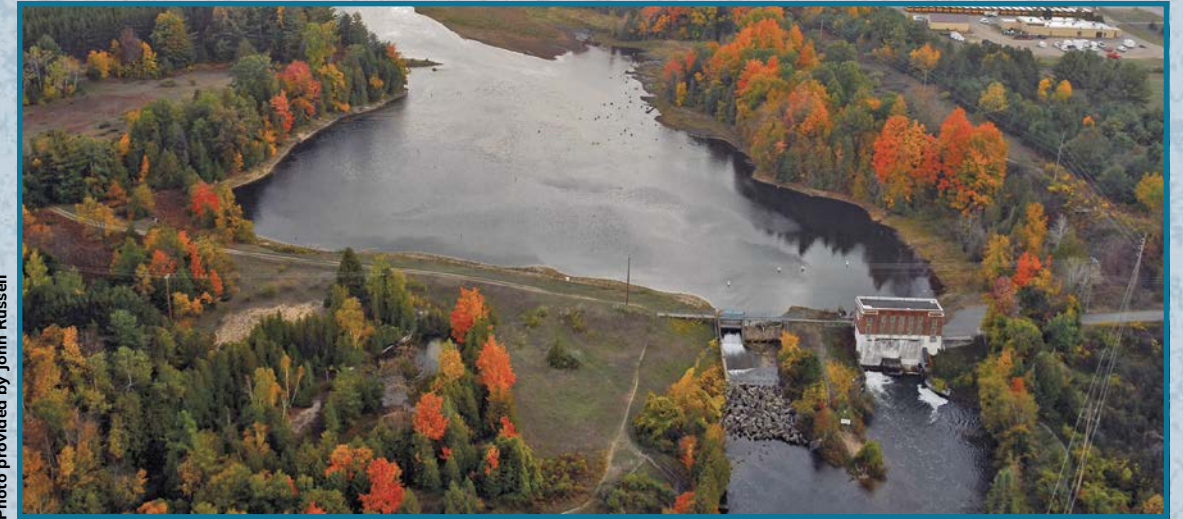
Underneath Sabin's impoundment were years of accumulated sand and sediment. All sediment was kept on-site and smoothed into adjacent upland areas outside of the river channel and its floodplain. (October 2012)

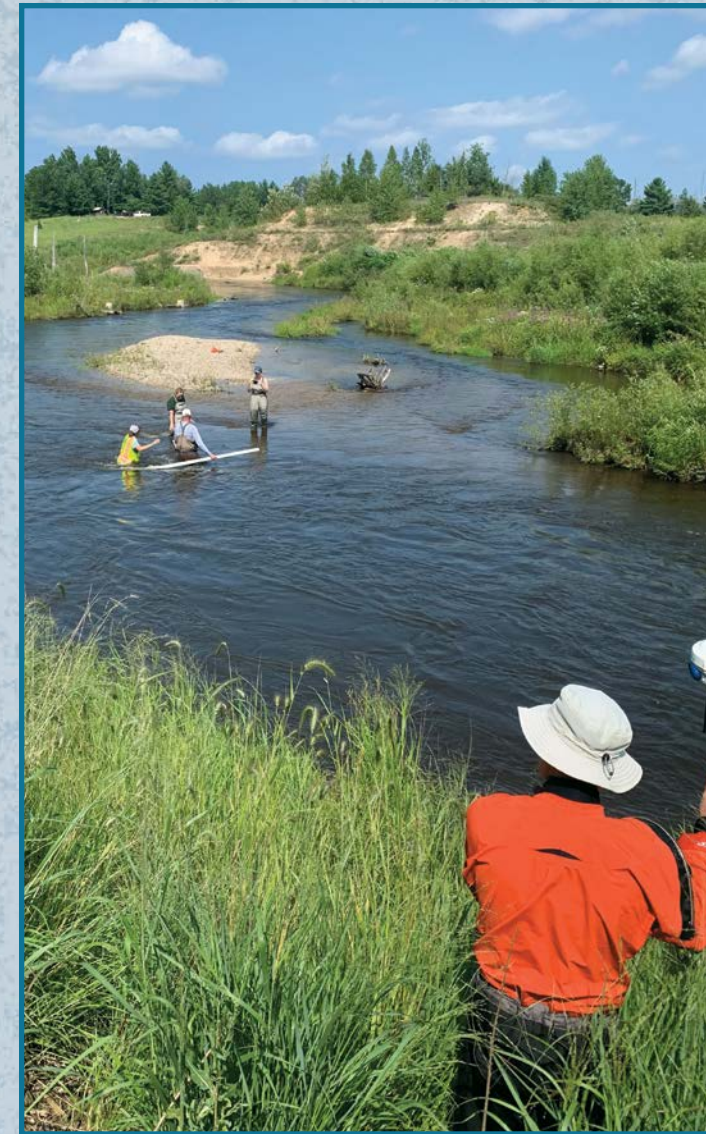
Scientists measure the river depth and width to assess how it is evolving since the dam removals. (August 2021)

- **Grand Traverse Band of Ottawa and Chippewa Indians** contracted with Stream Mechanics to monitor stream channel development at the former Boardman and Sabin dam sites with MDNR grant funding from 2018 through 2021. The stream channel, gravel beds, pools, floodplains, riparian vegetation, and instream wood were measured and documented in certain locations. General observations include that the channel is functioning and still adjusting while the streambanks become more rooted with plant and tree life.
